## REPORT No. 060265-9-a

<b>CUSTOMER</b>	TÉCNICAS EXPANSIVAS S.L. (INDEX)
<b>CONTACT PERSON</b>	EDUARDO POZA
<b>ADDRESS</b>	P.I. La Portalada II, c/ Segador 13 26006 Logroño (La Rioja)
<b>PURPOSE</b>	DETERMINATION OF UPLIFT RESISTANCE OF INSTALLED CLAY OR CONCRETE ROOF TILES ROOF SYSTEM TEST METHOD ACCORDING TO UNE-EN 14437: 2007 STANDARD
<b>TESTED SAMPLE</b>	POLYURETHANE FOAM REF.: "PU-TC and PU-TP ROOFING TILES"
<b>DATE OF RECEIPT</b>	26/09/2016
<b>TEST DATES</b>	30/09/2016 – 27/10/2016
<b>DATE OF ISSUE</b>	12/02/2019
<b>DATE OF TRANSLATION</b>	13/02/2019

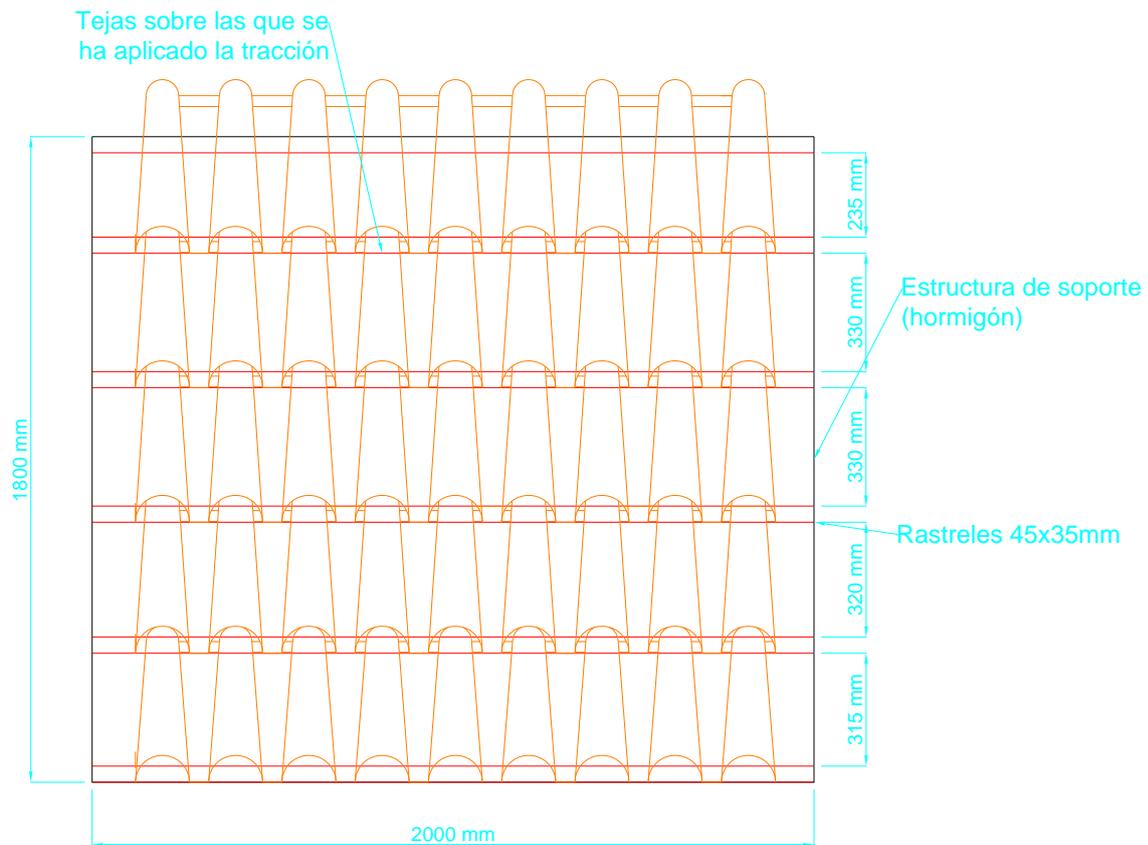
Figure 1: Plan with roof tile layout

To conduct the tests, a support structure was built on which the tiles were arranged according to the layout shown in Figures 1 and 2 (drawings are carried out in a descriptive manner. The set-up can slightly vary depending on the type of tile used)

The support structure is formed by steel tubing on which 10 cm-sided wood joists have been placed. Prefabricated concrete slabs are placed on the joist to simulate the concrete on the roof. 45x35 mm-section wood battens are placed on the concrete and roof tiles are fixed over them with polyurethane FOAM. The support structure holding the roof tiles forms a 45° angle with the horizontal plane.

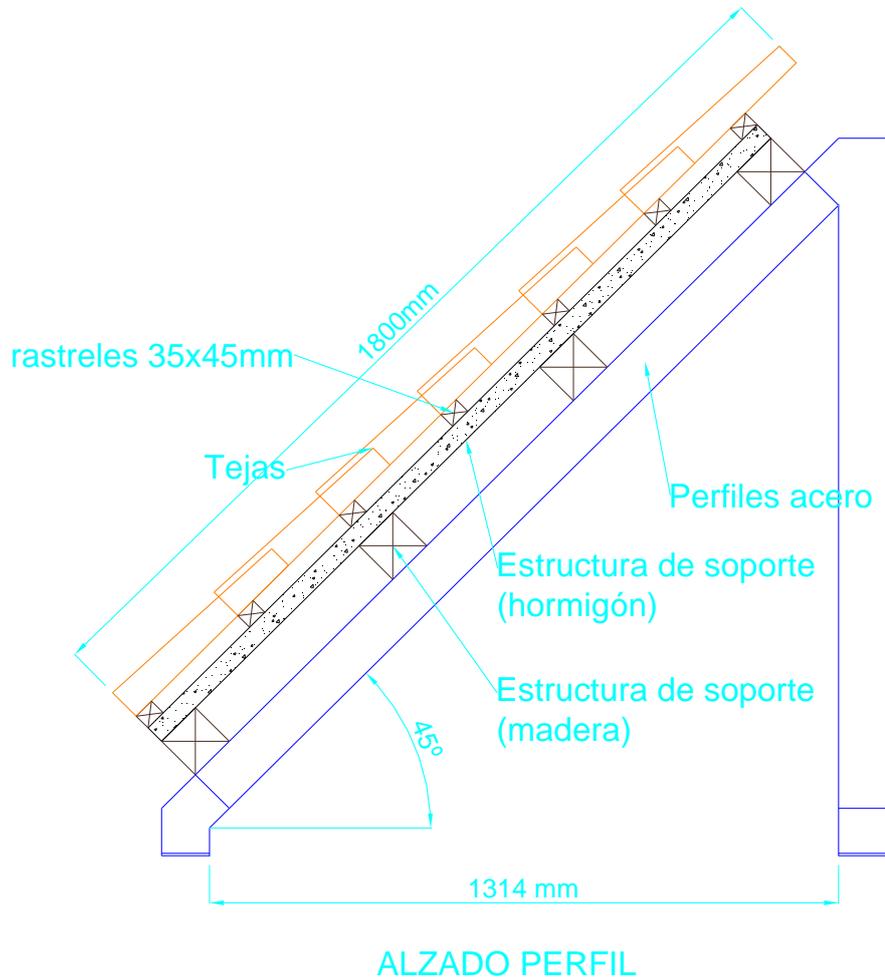
Figure 2: Profile of the support structure with tile layout

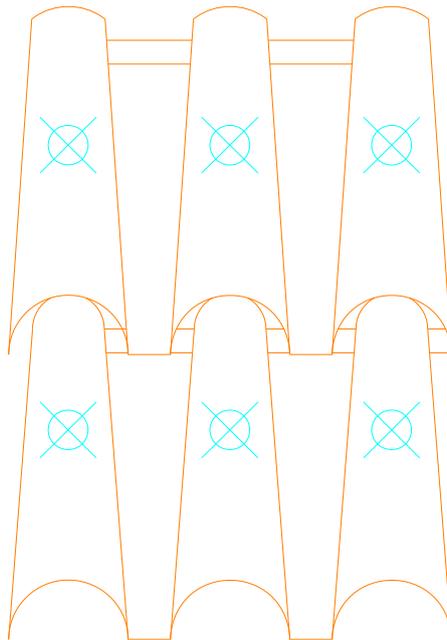
Figure 3: Hole position for placing the cables in the tiles

A hole (at least 10 mm in diameter) is made on each one of the tiles to place the traction cable as shown in Figures 3 and 4.

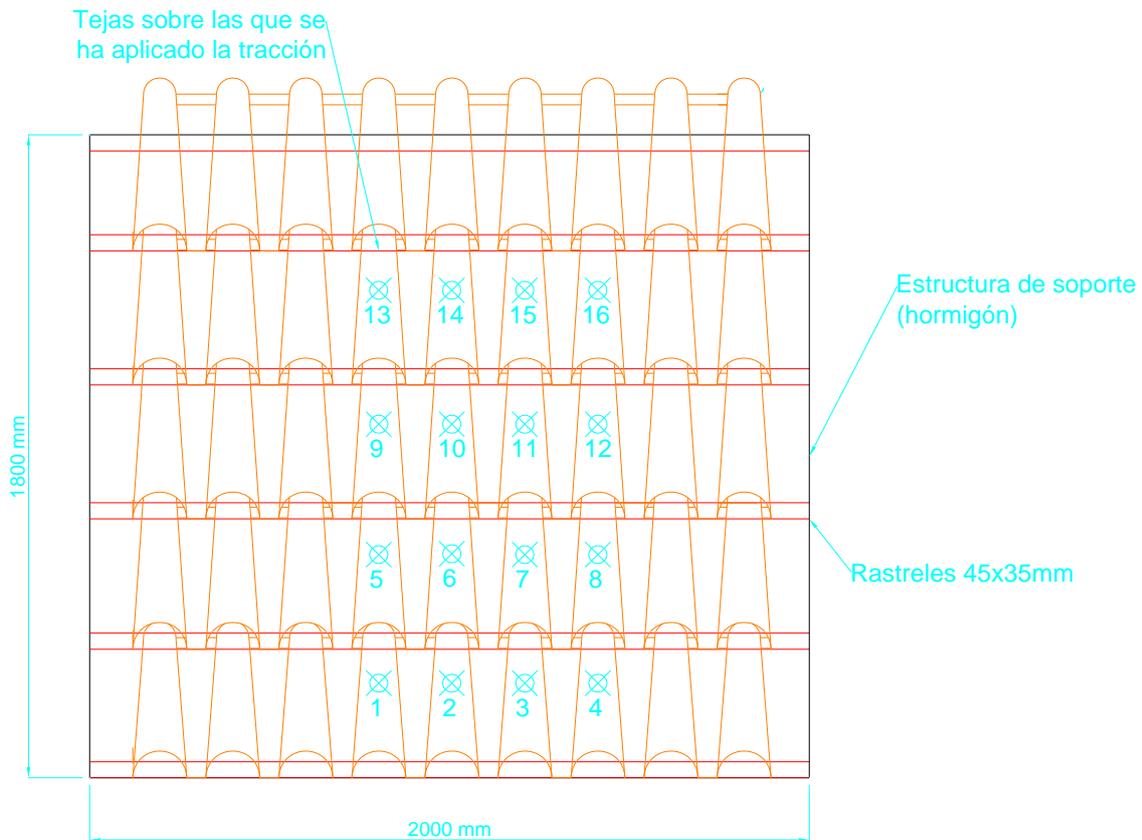
Figure 4: Position of perforations to join the traction cables to the tiles and identification of tile location.

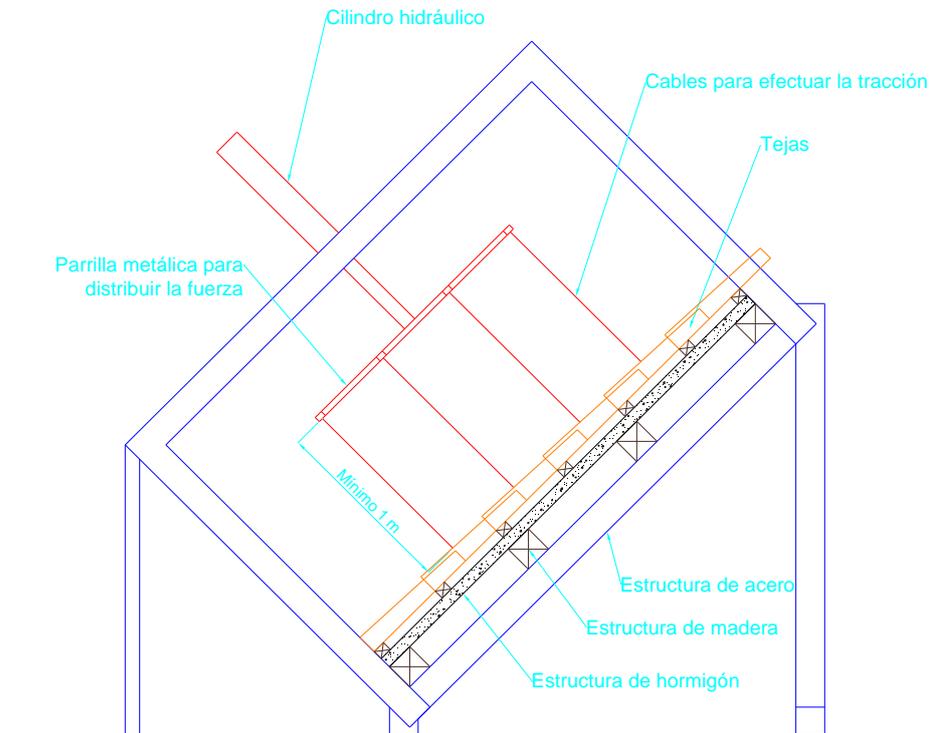
Figure 5: Side view of the whole system

A test trial of 16 roof tiles arranged as shown in figures 1 and 2 was conducted. The way they were positioned should represent their true position. The tested roof should have a minimum dimension of (1.5x1.5) m. The force is applied perpendicular to the roof by a cable system as presented in Figure 5.

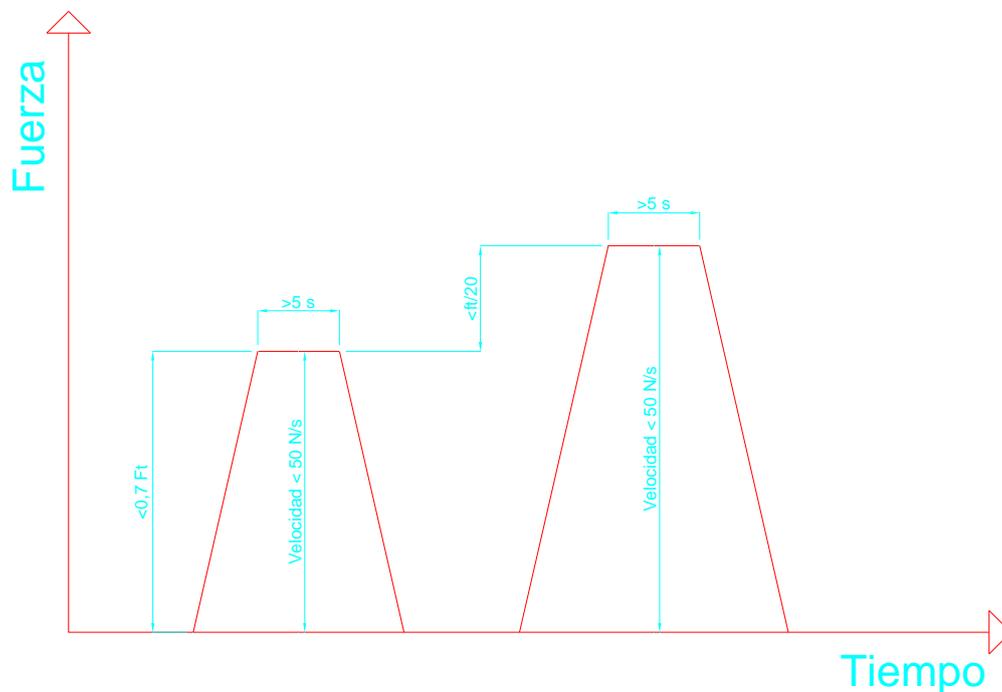
Figure 6: Force application procedure.

According to the previously explained basic test criteria, firstly the force should be applied at a maximum of  $0.7 F_t$ , and in subsequent steps at a maximum of  $1/20 F_t$  keeping its maximum level for at least 5 seconds. After that, it should be reduced to zero. The force should be increased and reduced at a maximum of 50 N/s.

The force application procedure is shown in Figure 5

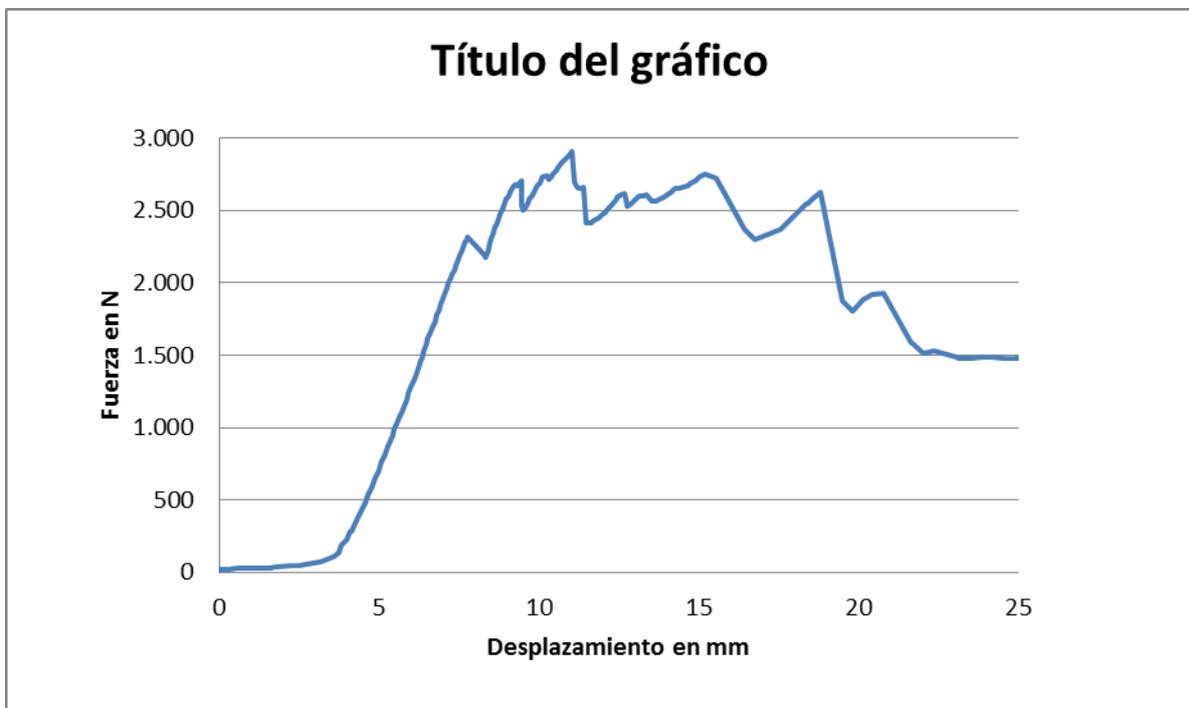
DESCRIPTION:	Applied force (N)
MAXIMUM LOAD REACHED IN INITIAL TEST	2,904
TYPE OF FAILURE	Tile uplift
MAXIMUM DEFORMATION ZONE	
CENTRAL ZONE

Graph 1: Load

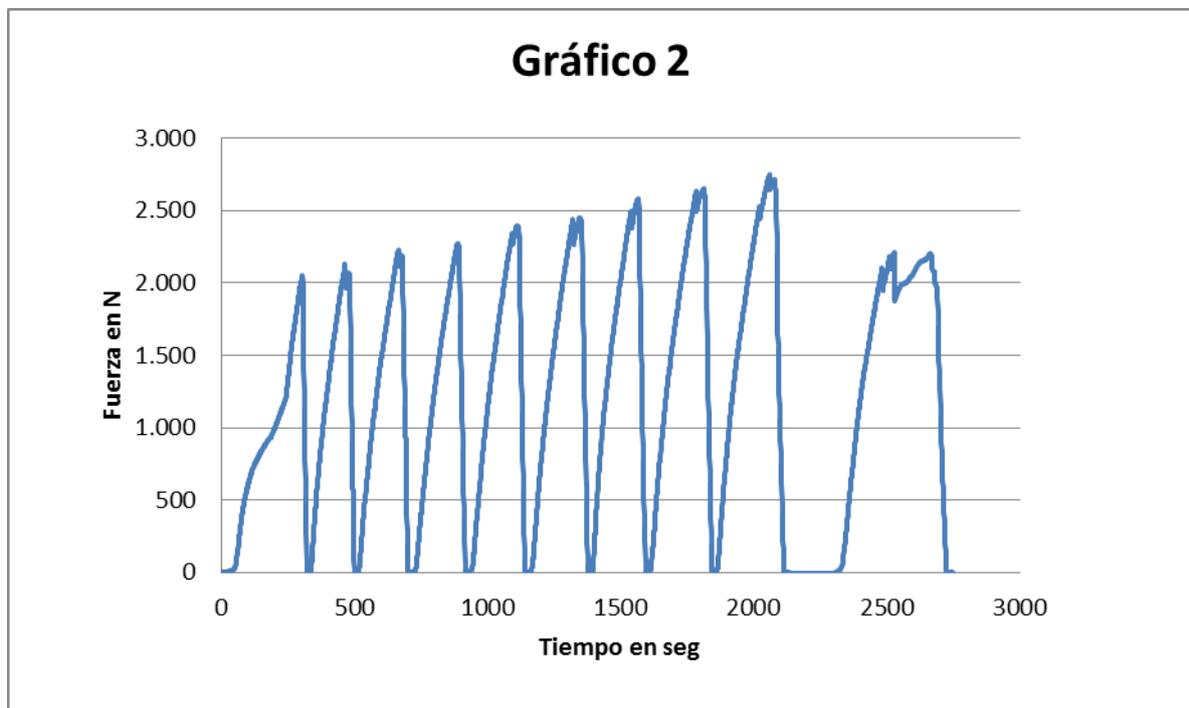
DESCRIPTION:	Applied force (N)
70% OF INITIAL MAXIMUM LOAD	2,032.8
<b>MAXIMUM LOAD <math>R_{r,1}</math></b>	<b>2,739</b>
TYPE OF FAILURE	Tile uplift when reaching 2,840
MAXIMUM DEFORMATION ZONE	
CENTRAL ZONE

Graph 2: Load – Time in test 2

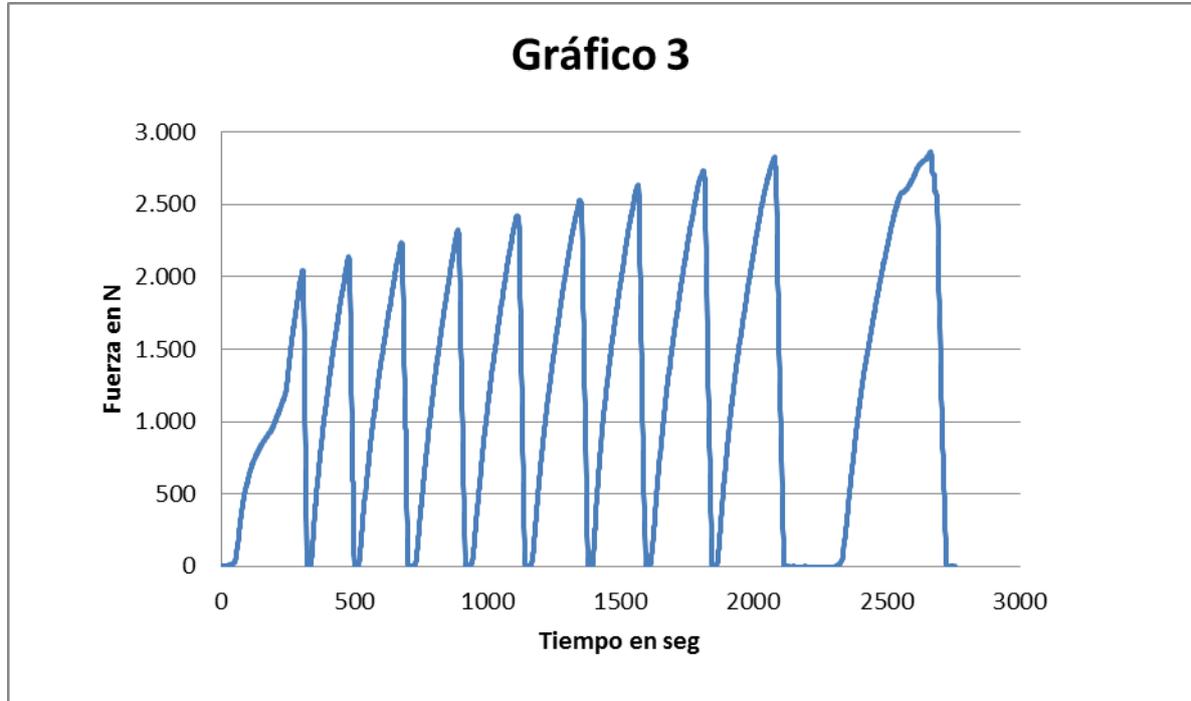
DESCRIPTION:	Applied force (N)
70% OF INITIAL MAXIMUM LOAD	2,032.8
<b>MAXIMUM LOAD R<sub>r,1</sub></b>	<b>2,840</b>
TYPE OF FAILURE	Tile uplift
MAXIMUM DEFORMATION ZONE	
CENTRAL ZONE

Graph 3: Load – Time in test 3

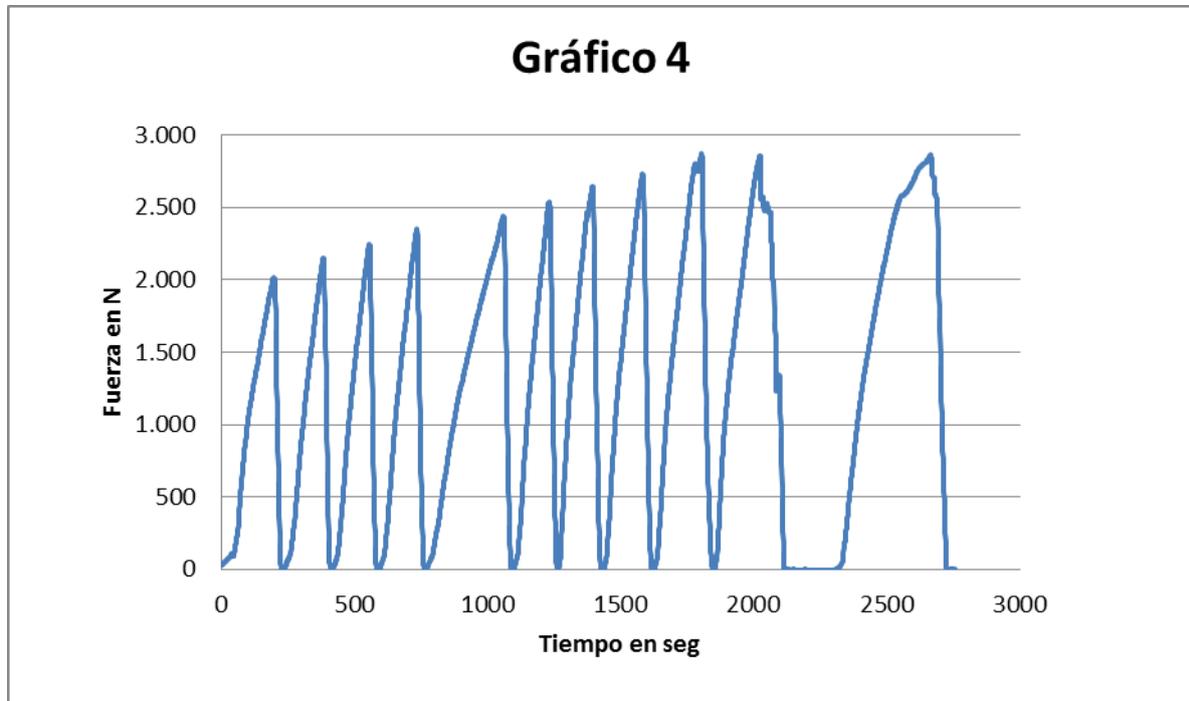
DESCRIPTION:	Applied force (N)
70% OF INITIAL MAXIMUM LOAD	2,032.8
<b>MAXIMUM LOAD <math>R_{r,1}</math></b>	<b>2,840</b>
TYPE OF FAILURE	Tile uplift
MAXIMUM DEFORMATION ZONE	
CENTRAL ZONE

Graph 4: Load – Time in test 4
